Investigation report

***Ady Gil and  
Shonan Maru No.2***

Collision on 6 January 2010

Maritime New Zealand

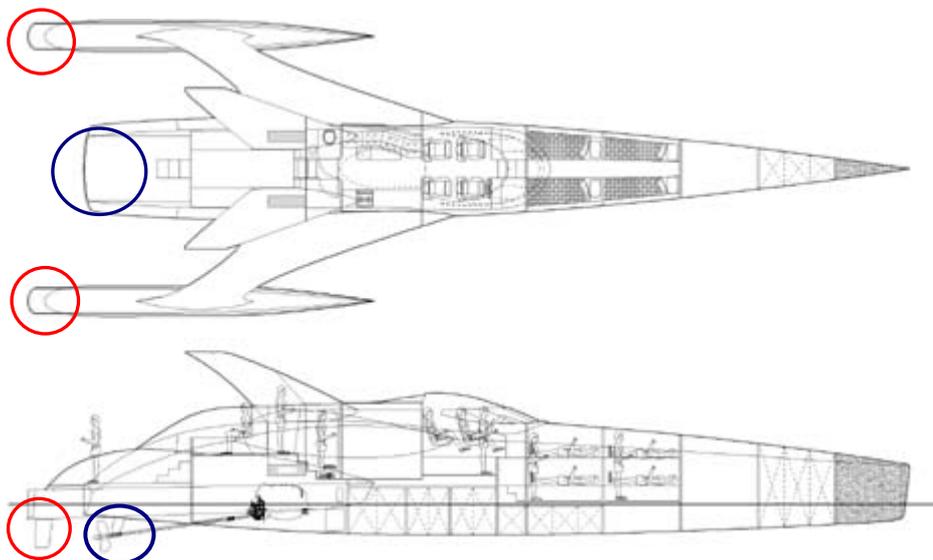
62. A few days prior to the collision, the manual steering helm was found to have minor problems and the vessel was reportedly being steered under auto helm, which involves controlling the rudder with a dial control or buttons. This is a longer process than simply turning a wheel. This manner of steering is not as effective at low speeds or in conditions of moderate sea or swell.

**Figure 4** Diagram showing *Ady Gil*'s rudder and propeller positions  
(Diagram courtesy of *Ady Gil*'s designer)

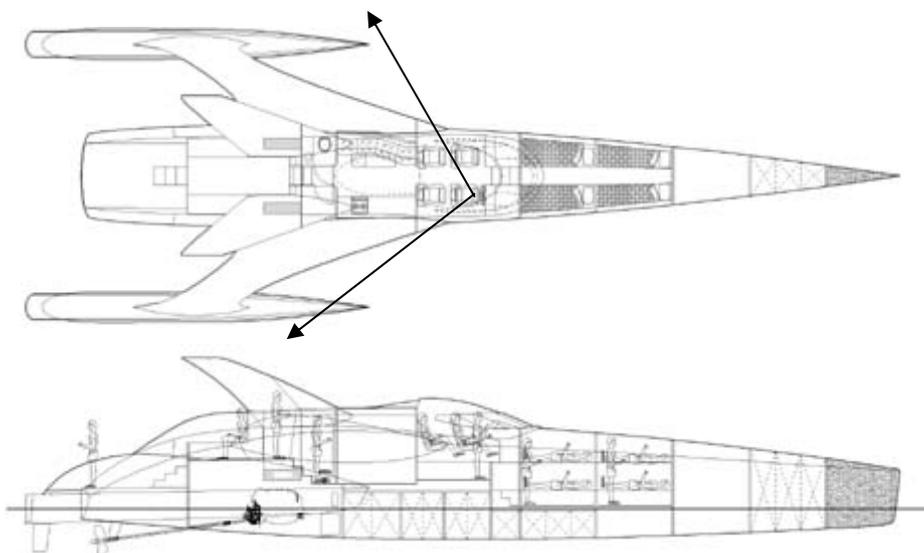
63. **Ady Gil**'s forward windscreen was relatively small and designed to withstand the impact of waves. General visibility astern from the conning position was very limited, with only a small window providing any visibility directly astern. The master explained visibility from the helm as follows:

64. Accordingly, the helmsman<sup>10</sup> relied on verbal commands from a crewman standing at the stern when reversing or for maintaining a general lookout. Verbal commands would usually be done using handheld VHF radios, although radios were not used when engaging with the whaling fleet because of concerns they would be overheard. Alternatively, voice commands were relied on.

**Figure 5** **Ady Gil**'s approximate area of visibility

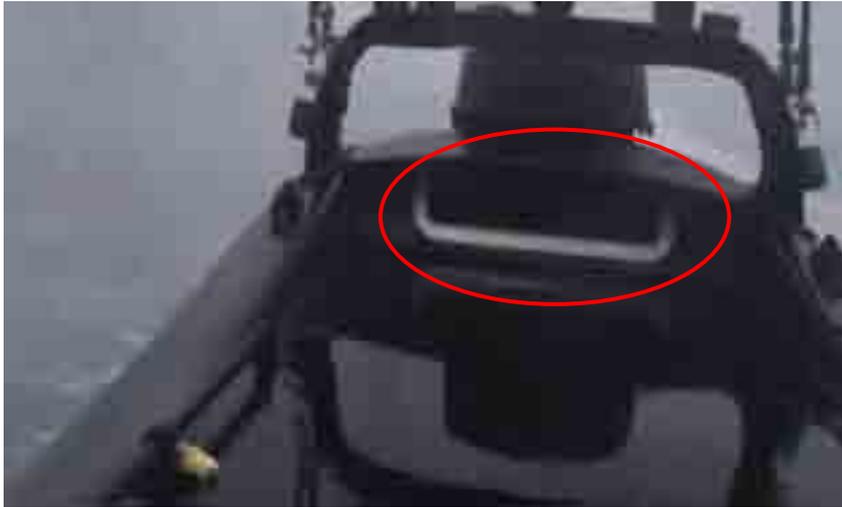
**Figure 8** Small window at rear of **Ady Gil**'s cockpit  
(Photograph courtesy of SSCS)

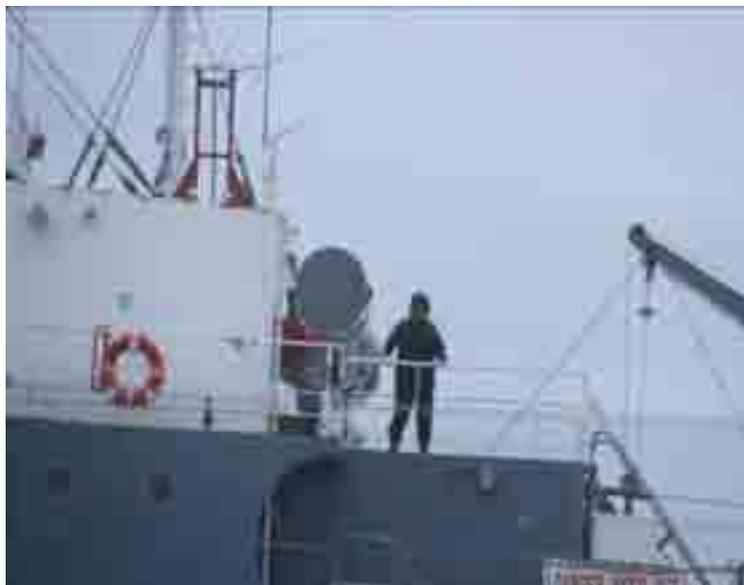
89. Following the warning, a long-range acoustic device (LRAD)<sup>15</sup> sounded from **Shonan Maru No. 2** caught the attention of the master and crew at the stern of **Ady Gil**, but not the attention of the helmsman, who remained unaware of **Shonan Maru No. 2**'s approach.

**Figure 10** **Shonan Maru No. 2**'s LRAD (the disc-shaped device at the centre of the photo)

15. LRADs are commonly used as a crowd-control or hailing device and emit a shrill, high-pitched tone of about 146 decibels at 1 metre. This is higher than the normal human pain threshold and capable of causing permanent hearing damage. At 300 metres they measure about 90 decibels, which is distracting and painful.

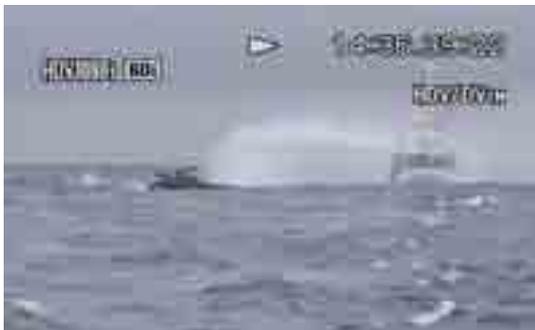
93. The information available suggests that, when **Shonan Maru No. 2** was approximately 130 metres away from **Ady Gil**, **Shonan Maru No. 2** steered so as to alter her track line some 13° degrees starboard (that is, from about 350°(T) to 014°(T). This alteration of course by **Shonan Maru No. 2** rendered a close quarters situation inevitable in the absence of either a further change of course by **Shonan Maru No. 2** or a change of course by **Ady Gil**. (Refer to Appendix 4 from Point D onwards, and to Appendix 5)

**Figure 12** *Shonan Maru No. 2* initiating a turn towards *Ady Gil*  
(Video courtesy of Lizard Productions)

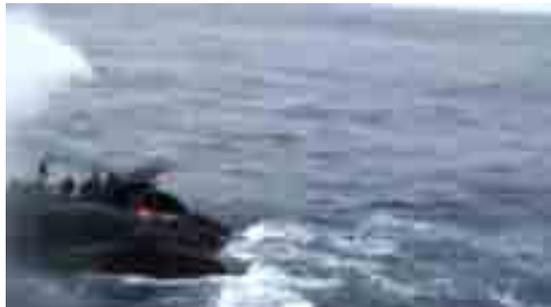
**Figure 16** Propeller wash indicating an increase of **Ady Gil**'s forward propulsion coinciding with the water monitors coming into range

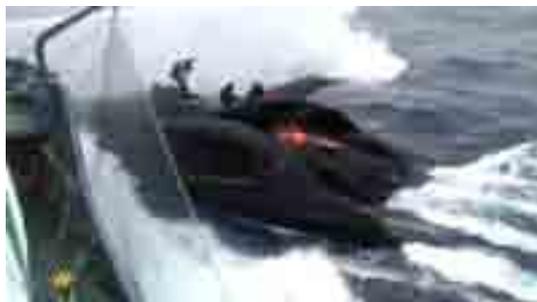
**Figure 17** Propeller wash showing a further increase in **Ady Gil**'s propulsion

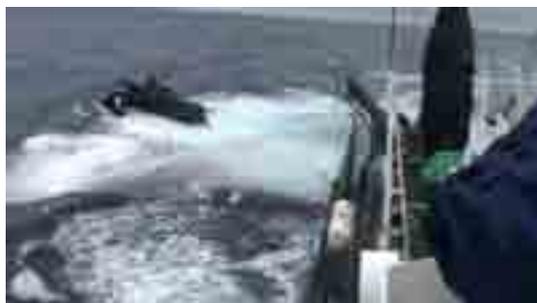
**Figure 18** Propeller wash showing **Ady Gil**'s astern propulsion

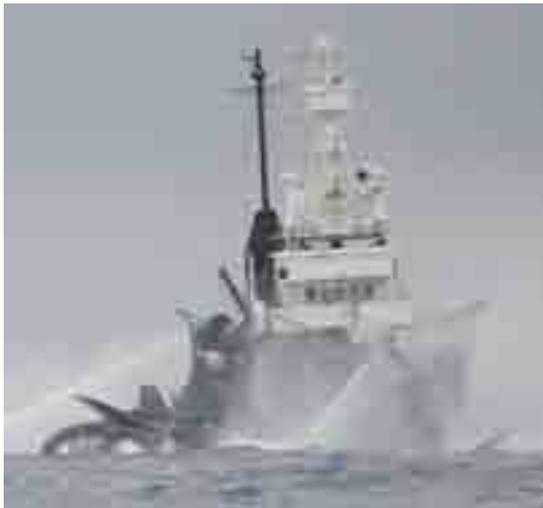
104. **Shonan Maru No. 2** and **Ady Gil** subsequently collided, striking **Ady Gil**'s bow and port sponson, taking approximately 3.5 metres off her bow. The moment of collision is shown in the photograph below. From the information available, it was not possible to plot accurately the final metres of each vessels track in relation to the other.

**Figure 19** Collision  
(Photograph courtesy of SSCS)

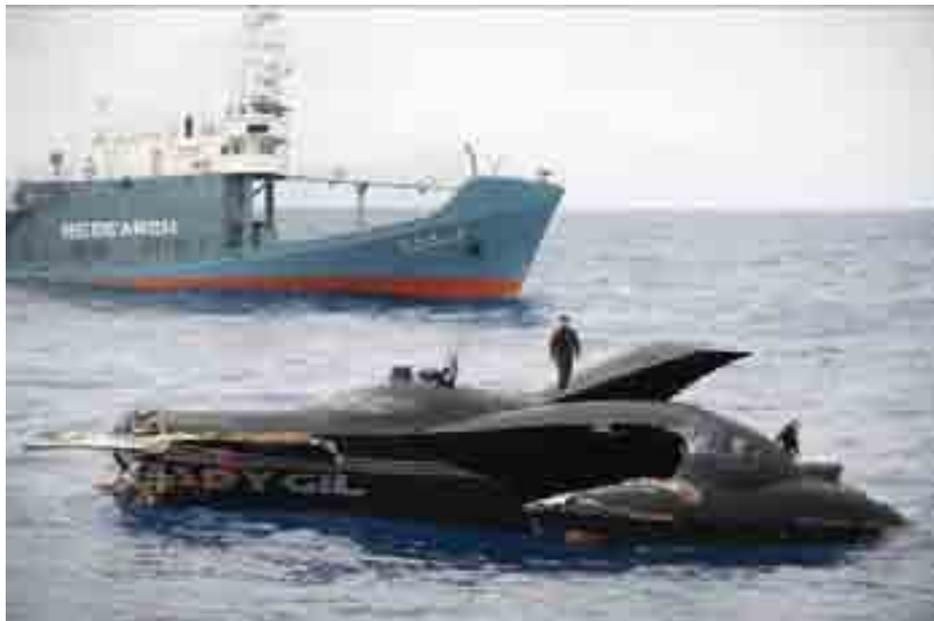
**Figure 20** Damage to *Ady Gil*

127. Inquiries were subsequently made with the manufacturer of *Ady Gil*. On assessing images of the damage sustained, the manufacturer expressed the opinion that the remainder of the hull, undamaged sponson and other watertight areas would be sufficient to keep the vessel afloat.

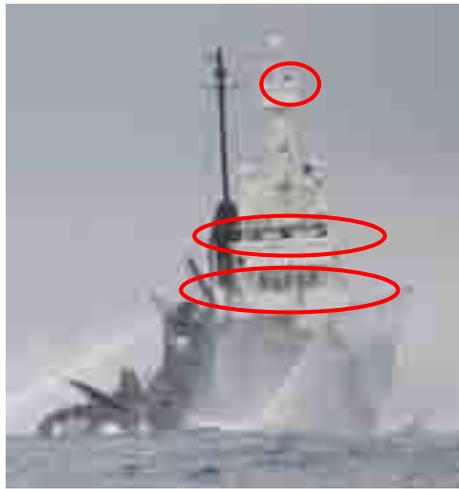
**Figure 22** Eight crew maintaining a lookout on **Shonan Maru No. 2**  
(Photograph courtesy of SCS)

153. There is no evidence to suggest that the lookout from **Shonan Maru No. 2** was ineffective. Therefore, the lookout maintained by **Shonan Maru No. 2** is not considered to be a factor in the collision.

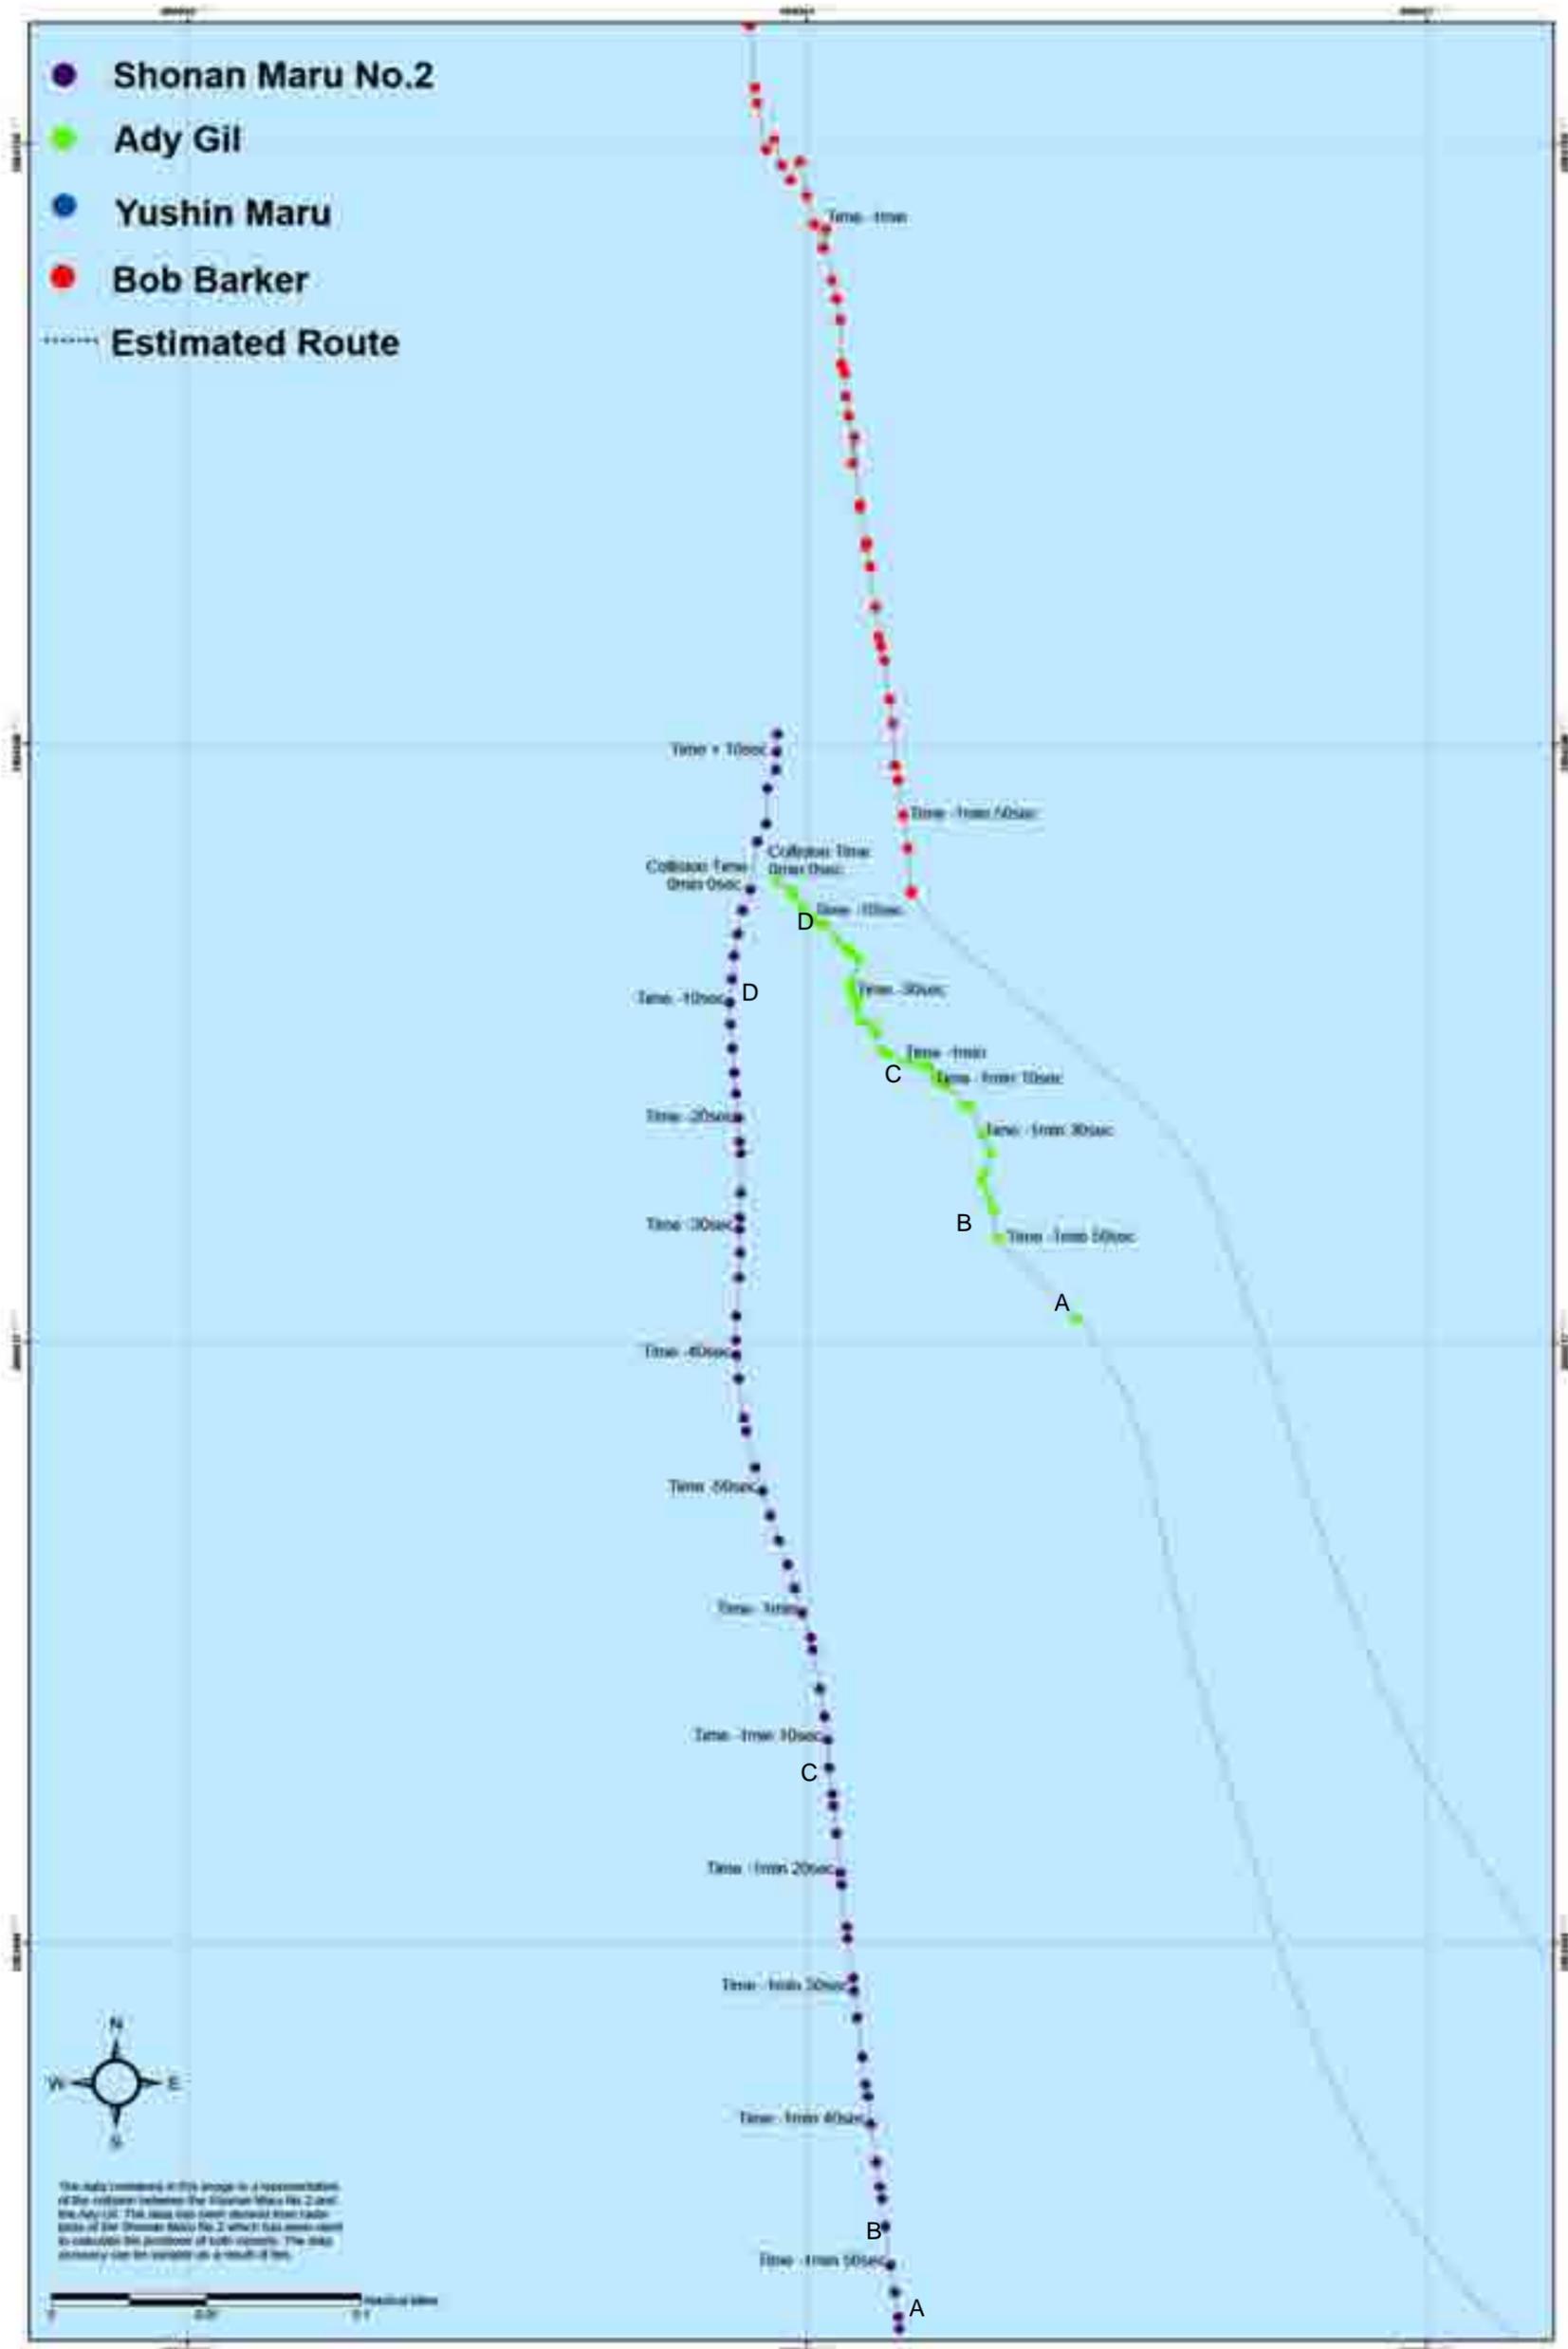
# Appendix 4: Vessel tracks

132. The track of *Yushin Maru No. 3* was plotted to ascertain whether or not its presence prevented *Ady Gil* or *Shonan Maru No. 2* from complying with the international collision regulations. *Yushin Maru No. 3* was found to be well clear of *Shonan Maru No. 2*, *Ady Gil* and *Bob Barker*. The same process was applied for the *Bob Barker*. For this reason, investigators were able to rule out the possibility that *Yushin Maru No. 3* or *Bob Barker* limited the manoeuvrability of any other vessel or contributed to the collision. (Refer to Appendix 4)
