Investigation report

***Ady Gil and  
Shonan Maru No.2***

Collision on 6 January 2010

Maritime New Zealand

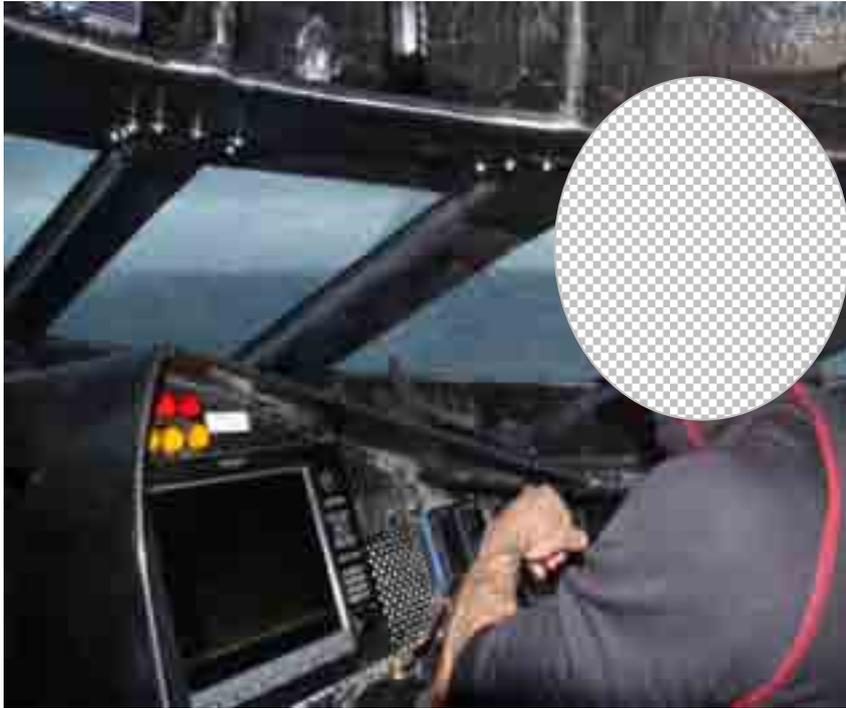
**Figure 6** View forward and starboard from **Ady Gil**'s helm  
(Photograph courtesy of SSCS)

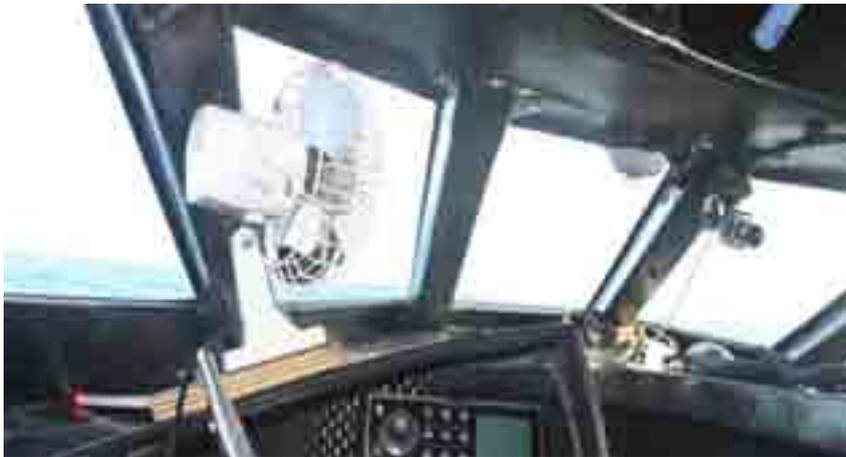
**Figure 7** View forward from port side of **Ady Gil**  
(Photograph courtesy of SSCS)

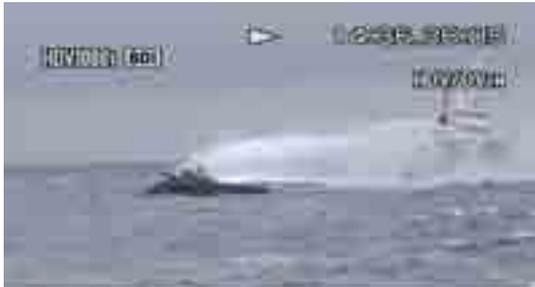
**Figure 11** *Shonan Maru No. 2* approaching *Ady Gil*  
(Video courtesy of Lizard Productions)

94. The following screenshots show the final seconds prior to the collision. Note that *Shonan Maru No. 2* appears to be yawing, which resulted in the vessel's heading continually changing.

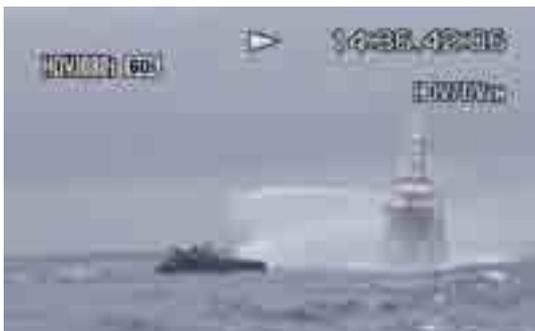
**Figure 13** *Shonan Maru No. 2* and *Ady Gil*  
(Video courtesy of Lizard Productions)

93. The information available suggests that, when **Shonan Maru No. 2** was approximately 130 metres away from **Ady Gil**, **Shonan Maru No. 2** steered so as to alter her track line some 13° degrees starboard (that is, from about 350°(T) to 014°(T). This alteration of course by **Shonan Maru No. 2** rendered a close quarters situation inevitable in the absence of either a further change of course by **Shonan Maru No. 2** or a change of course by **Ady Gil**. (Refer to Appendix 4 from Point D onwards, and to Appendix 5)

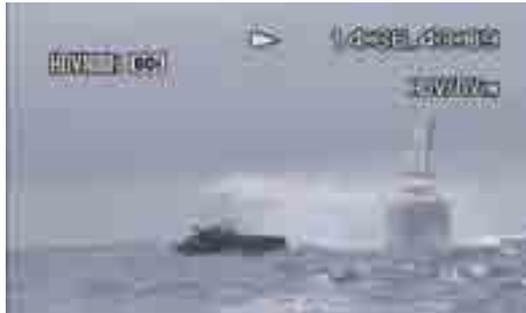
**Figure 14** **Shonan Maru No. 2** and **Ady Gil**  
(Video courtesy of Lizard Productions)

95. Shortly after the change of heading took effect, **Shonan Maru No. 2** came close enough for its water monitors to reach **Ady Gil**.
96. Although the exact timing cannot be determined, it was in the moments preceding the apparent alteration of course that the **Ady Gil** helmsman, alerted by the LRAD sounding, became fully aware of the situation developing. Prior to this his attention had been on other things and he had not been monitoring **Ady Gil**'s radar. He moved from his seat at the helm and looked astern out of the port cockpit window. He describes what he saw and did as follows:

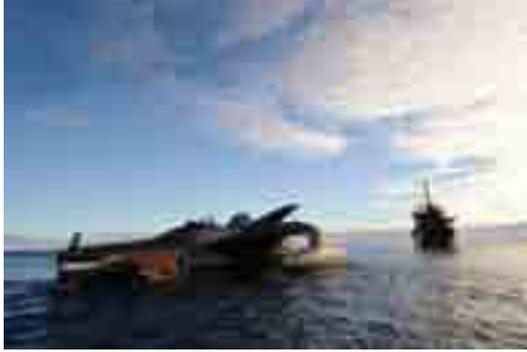
**Figure 21** **Ady Gil** under tow  
(Photograph courtesy of SCS)

111. The decision was made to tow *Ady Gil* to the French Antarctic base, Dumont d'Urville. In preparation for this, the helmsman, an engineer from *Bob Barker* and other crew set about draining *Ady Gil*'s fuel tanks. It was then discovered that fuel lines from the main and day tanks had been severed during the collision and sea water had leaked into the tanks. Residual fuel is believed to have leaked from the tanks.
112. *Ady Gil*'s master reported the collision and the potential for residual fuel leaking to the Australian authorities, prior to attempts being made to remove the fuel from the tanks.
113. With *Ady Gil* readied for towing, *Bob Barker* made a course for Dumont d'Urville with a speed of only two to three knots.

114. Around 0230–0300 hrs AEDT on 8 January 2010, **Ady Gil** was sitting low in the water and believed by crew on **Bob Barker** to be sinking. The master of **Ady Gil** was consulted and, with the view that the vessel was not likely to remain afloat, the decision was made to cut her free. **Ady Gil** was subsequently released from her tow and cast adrift to sink.
115. On 9 January 2010, the ICR faxed MNZ advising that it had located **Ady Gil** drifting at a position of 64° 27.7'S, 143° 03.4'E. The ICR also alleged that **Ady Gil** was leaking oil. This is believed to be residual oil leaking as a result of damage sustained in the collision.
